Fire resistance test report

Test standard: [Sections 2 and 10 of AS 1530.4:2014](#)

Test sponsor: [H.B. Fuller Australia](#)

Job number: [FRT220129](#)

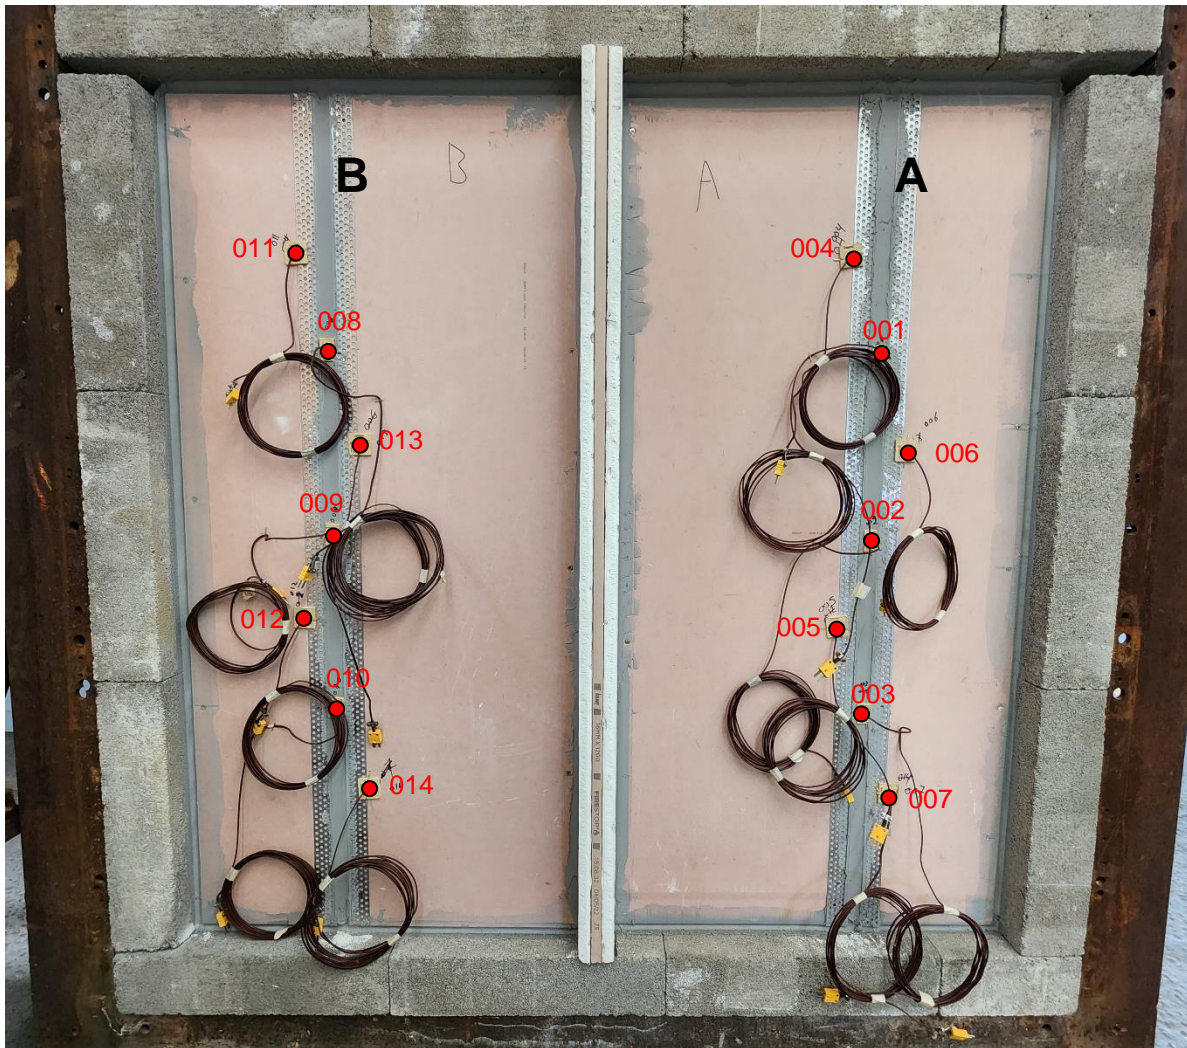
Figure 10 Instrumentation locations

Control joint	T/C #	Description
A	001	On the control joint, 250 mm up from the centre.
	002	On the control joint, at the centre.
	003	On the control joint, 250 mm down from the centre.
	004	25 mm from the control joint, 375 mm up from the centre.
	005	25 mm from the control joint, 125 mm down from the centre.
	006	25 mm from the control joint, 125 mm up from the centre.
	007	25 mm from the control joint, 375 mm down from the centre.
B	008	On the control joint, 250 mm up from the centre.
	009	On the control joint, at the centre.
	010	On the control joint, 250 mm down from the centre.
	011	25 mm from the control joint, 375 mm up from the centre.
	012	25 mm from the control joint, 125 mm down from the centre.
	013	25 mm from the control joint, 125 mm up from the centre.
	014	25 mm from the control joint, 375 mm down from the centre.

Start of the test	20 °C	Minimum temperature	20 °C	Maximum temperature	25 °C
Start of the test	20 °C						
Minimum temperature	20 °C						
Maximum temperature	25 °C						
Test duration	121 minutes						
Instrumentation and equipment	<p>The instrumentation was provided in accordance with AS 1530.4:2014 as follows:</p> <ul style="list-style-type: none"> The furnace temperature was measured by four mineral insulated metal sheathed (MIMS) Type K thermocouples – with wire diameters not greater than 1 mm, an overall diameter of 3 mm, and the measuring junction insulated from the sheath. The thermocouples protruded a minimum of 25 mm from steel supporting tubes. The unexposed side specimen temperatures were measured by Type K thermocouples with wire diameters less than 0.5 mm soldered to 12 mm diameter x 0.2 mm thick copper discs covered by 30 mm x 30 mm x 2.0 mm thick inorganic insulating pads. The thermocouple positions are shown in Table 10 and in Figure 10 in Appendix D.

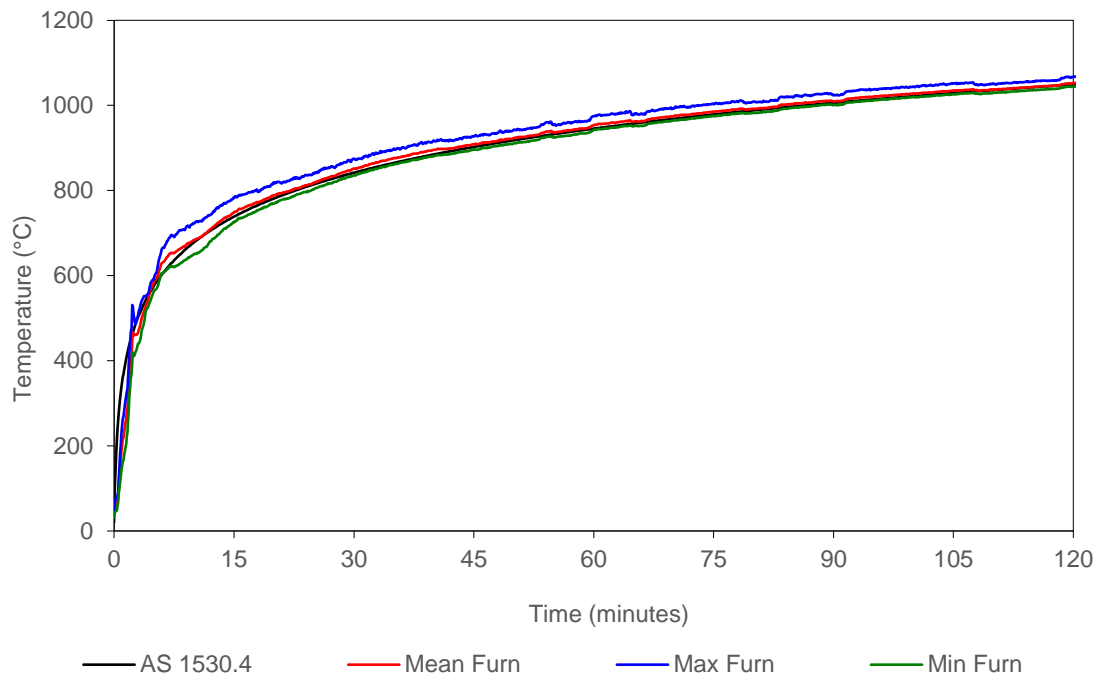
Figure 11 Furnace thermocouple temperature vs time

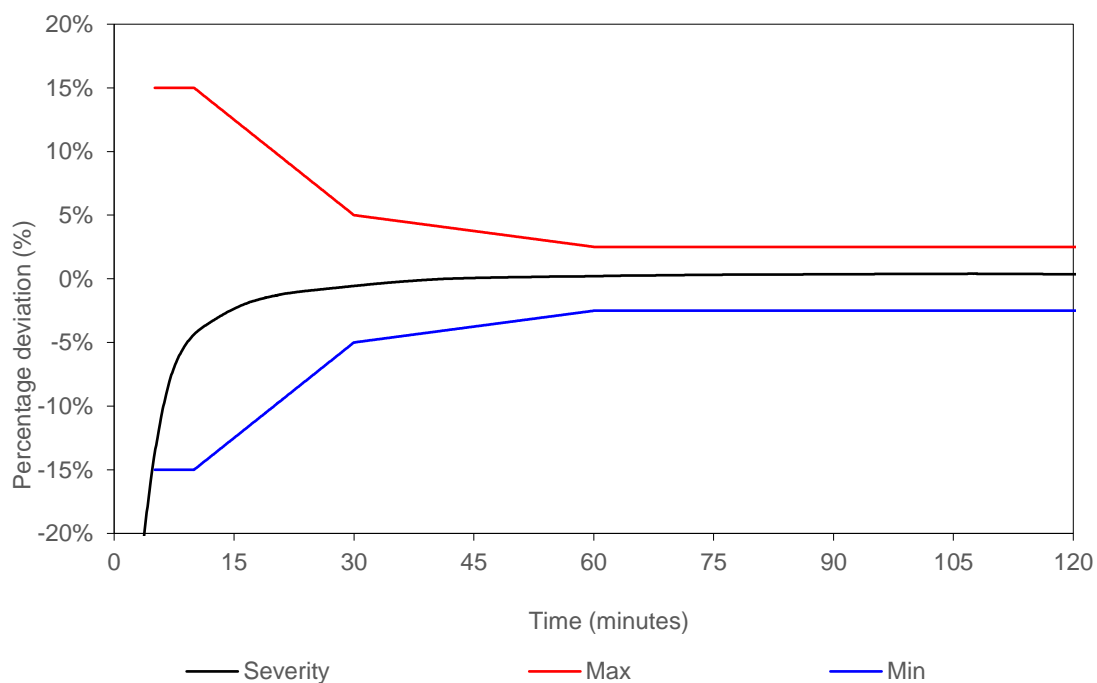
Figure 12 Percentage deviation of exposure severity vs time

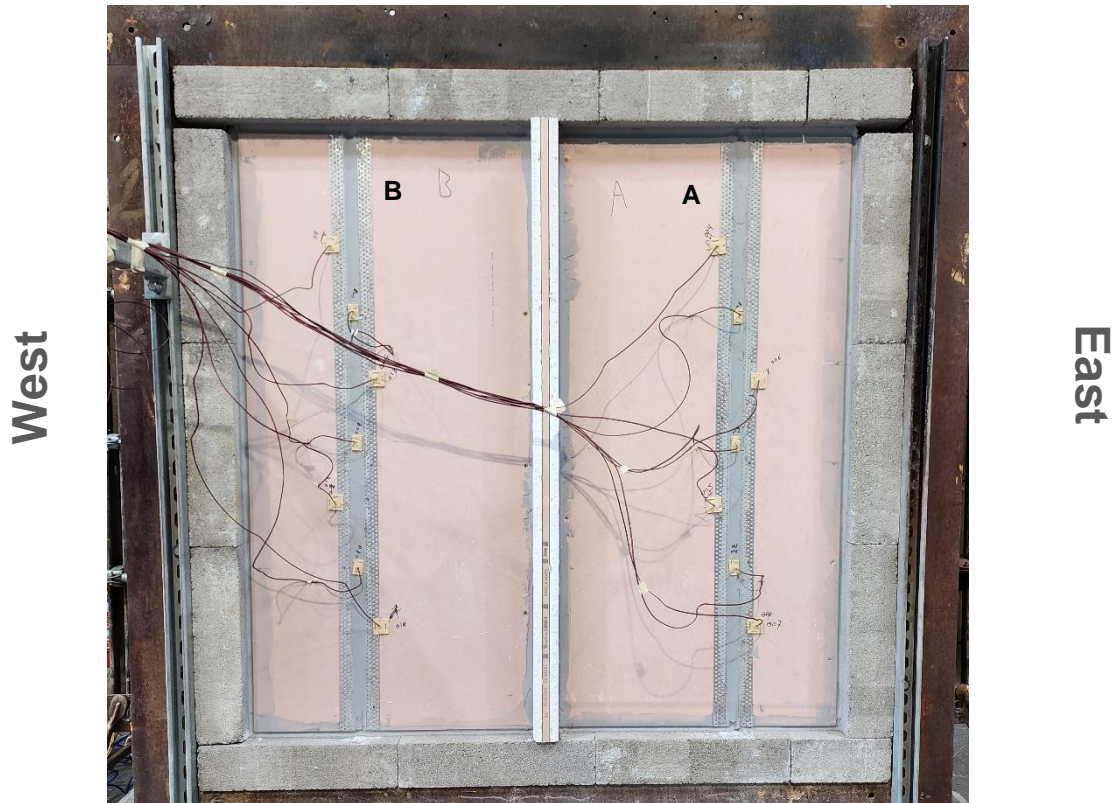
Figure 15 Unexposed face of the specimen before the start of the test

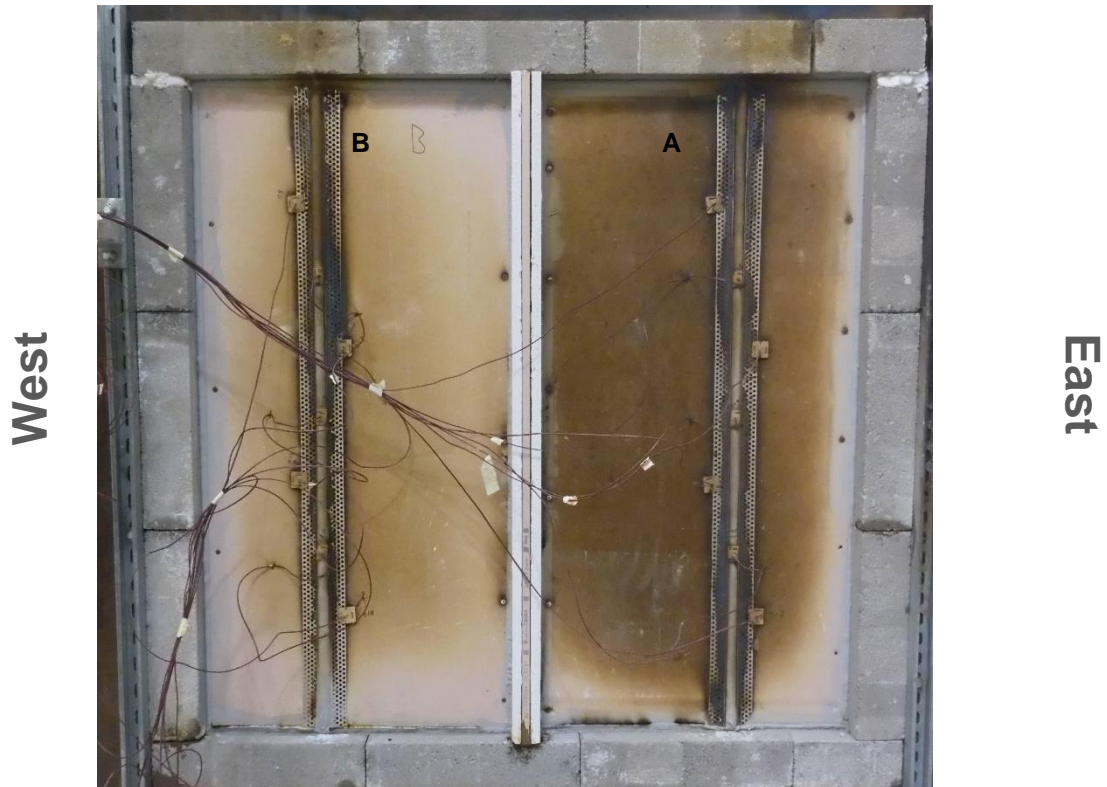
Figure 17 Unexposed face of the specimen at the end of the test
