FIRE TEST REPORT

FP18279-01-1

**THE FIRE RESISTANCE IN ACCORDANCE WITH
AS 1530.4:2014 OF SIX CONTROL JOINTS INSTALLED
IN A 240 MM THICK CONCRETE FLOOR SLAB**

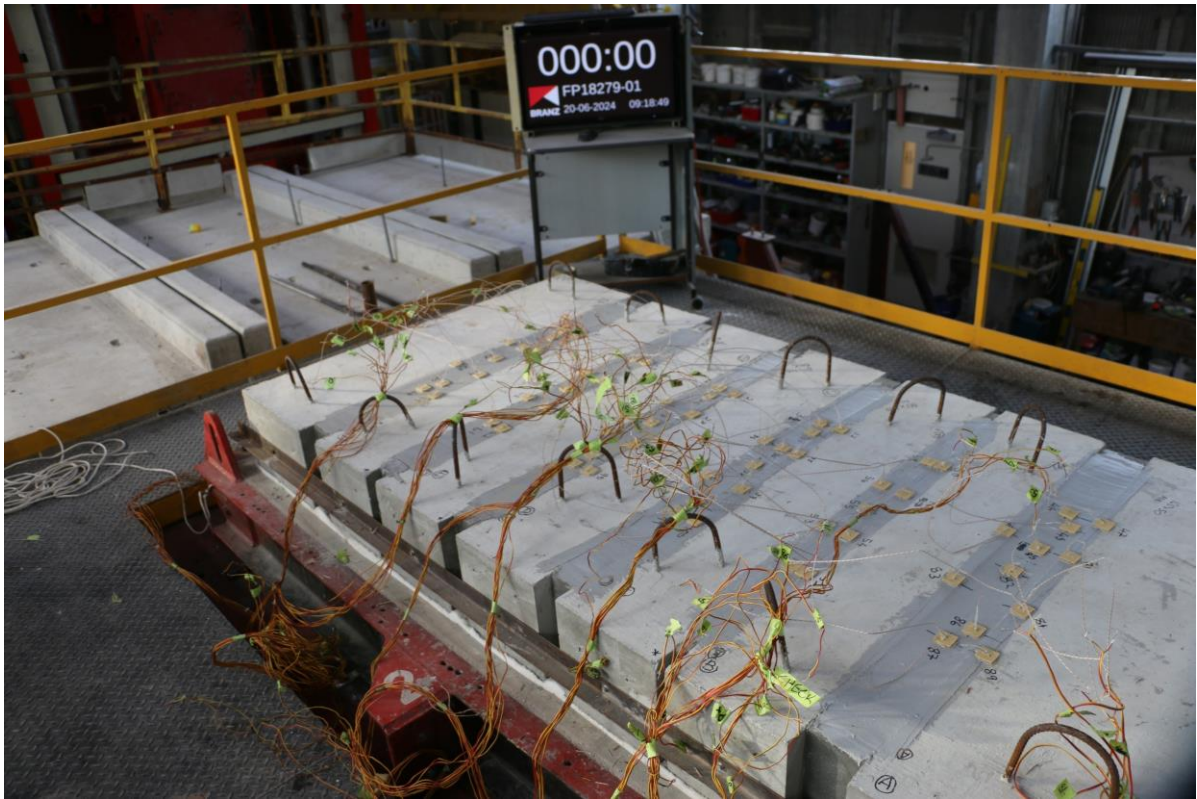
Photo 1: The Unexposed Face of the Assembly Prior to Testing

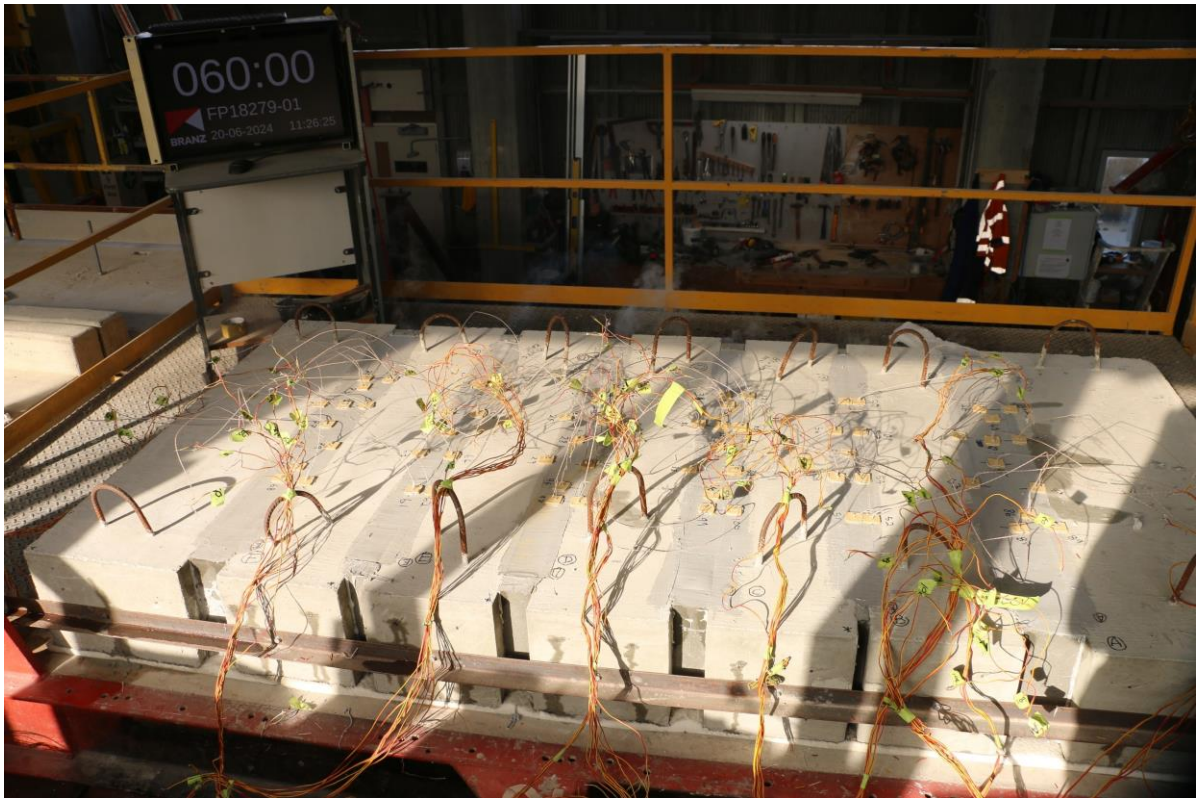
Photo 3: The Unexposed Face of the Test Assembly After a Duration of 60 Minutes

60:00	U	The sealant at TC 21 position on Control Joint E is beginning to swell up, the sealant at the South end of Control Joint D is slumping down.
80:00	U	Some of the areas of Control Joint D which had slumped down at 60 minutes have now begun to swell upwards.

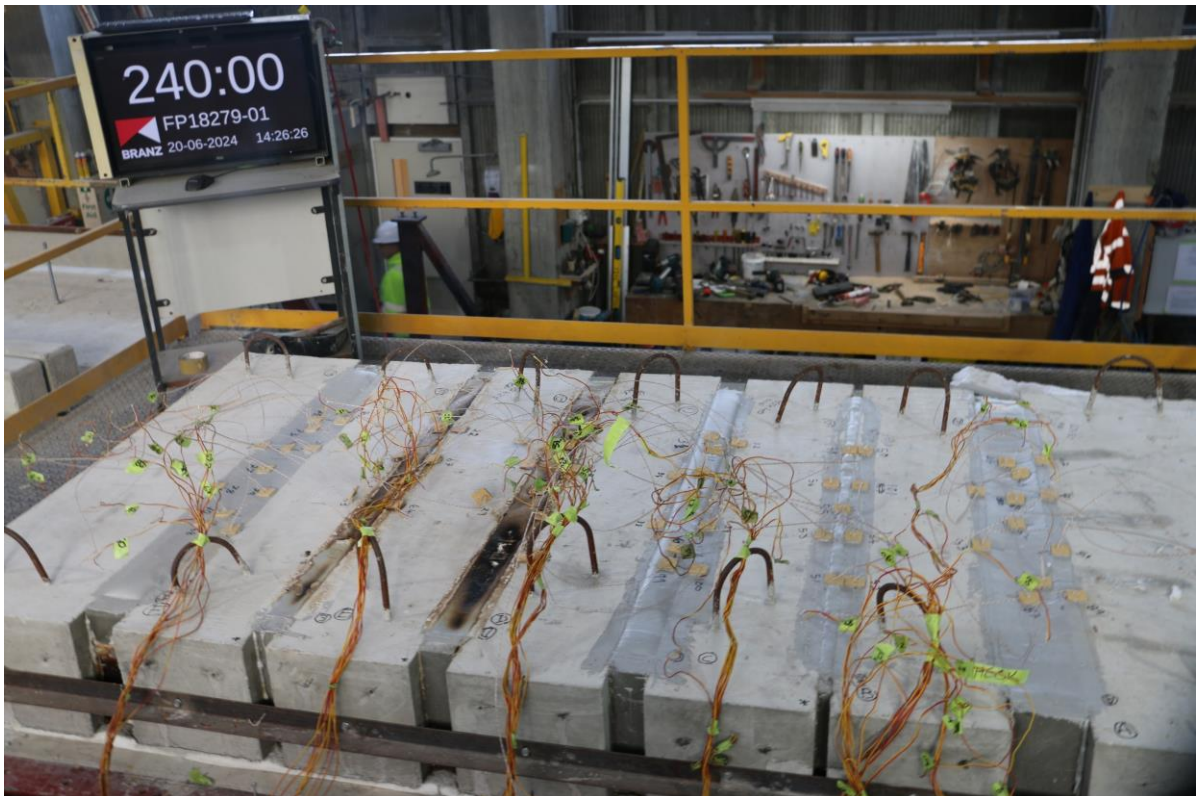
Photo 6: The Unexposed Face of the Test Assembly After a Duration of 240 Minutes

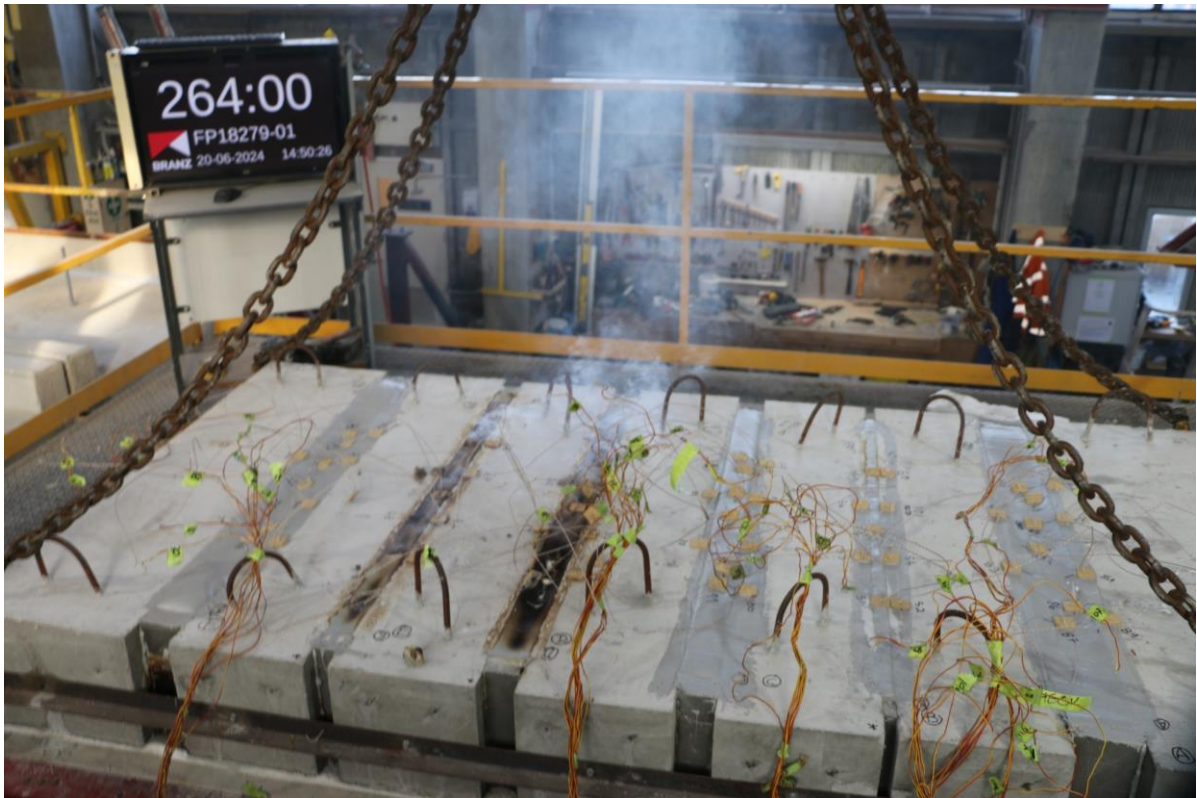
Photo 7: The Unexposed Face of the Test Assembly After a Duration of 264 Minutes
