FIRE TEST REPORT

FP19882-01-1

THE FIRE RESISTANCE IN ACCORDANCE WITH AS 1530.4:2014 OF SIX DOUBLE LAYER CONTROL JOINTS INSTALLED IN A 120 MM THICK CONCRETE FLOOR SLAB

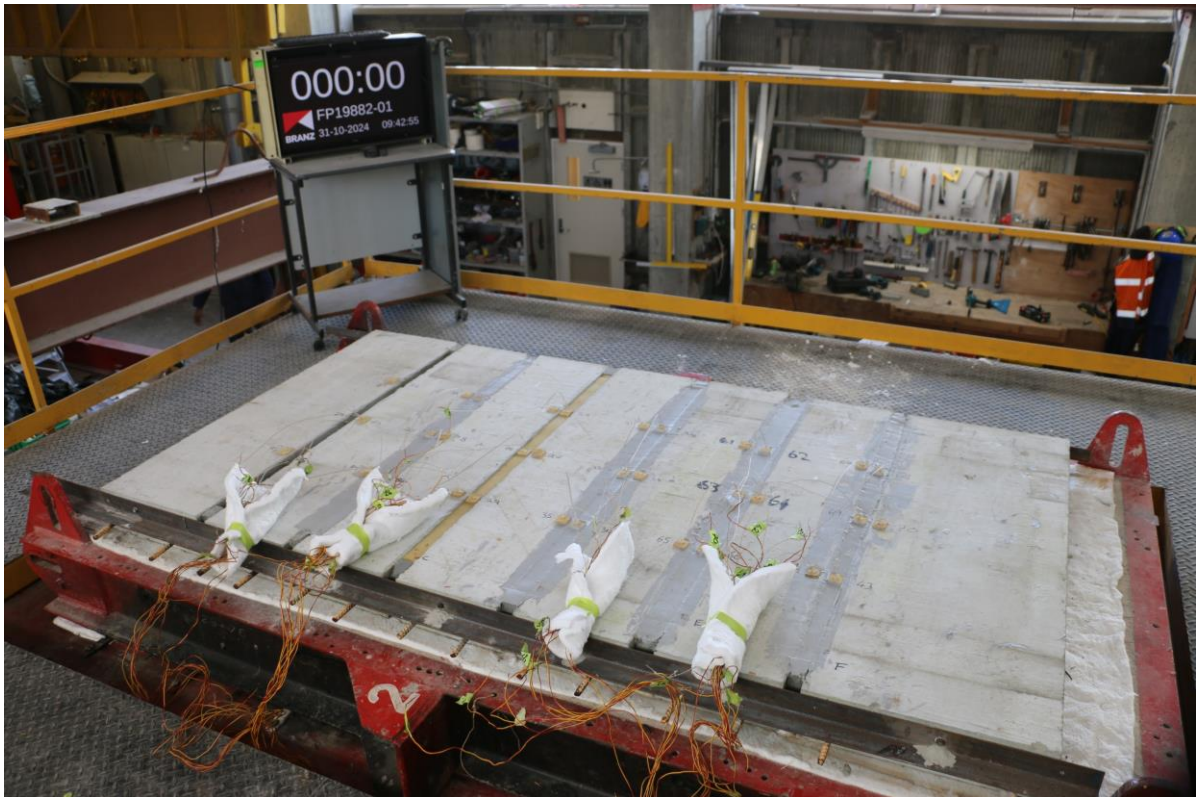
Photo 1: The Unexposed Face of the Assembly Prior to Testing

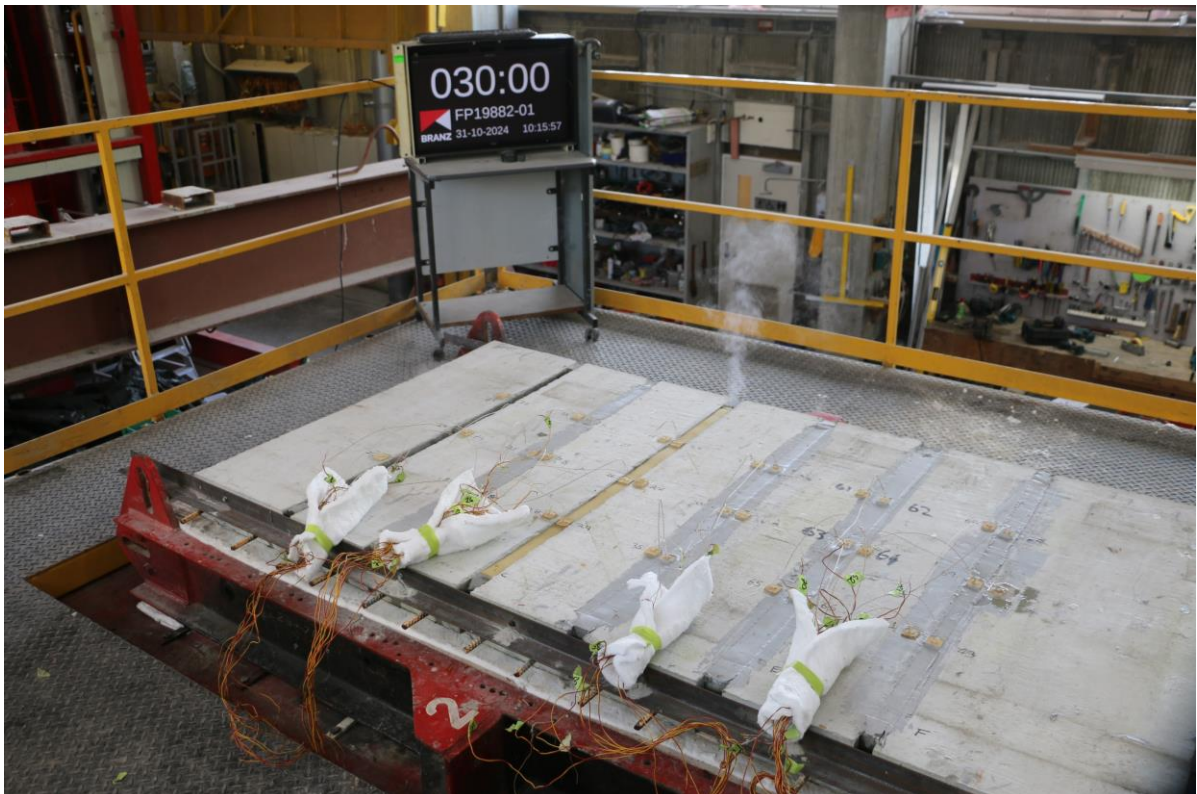
Photo 2: The Unexposed Face of the Test Assembly After a Duration of 30 Minutes

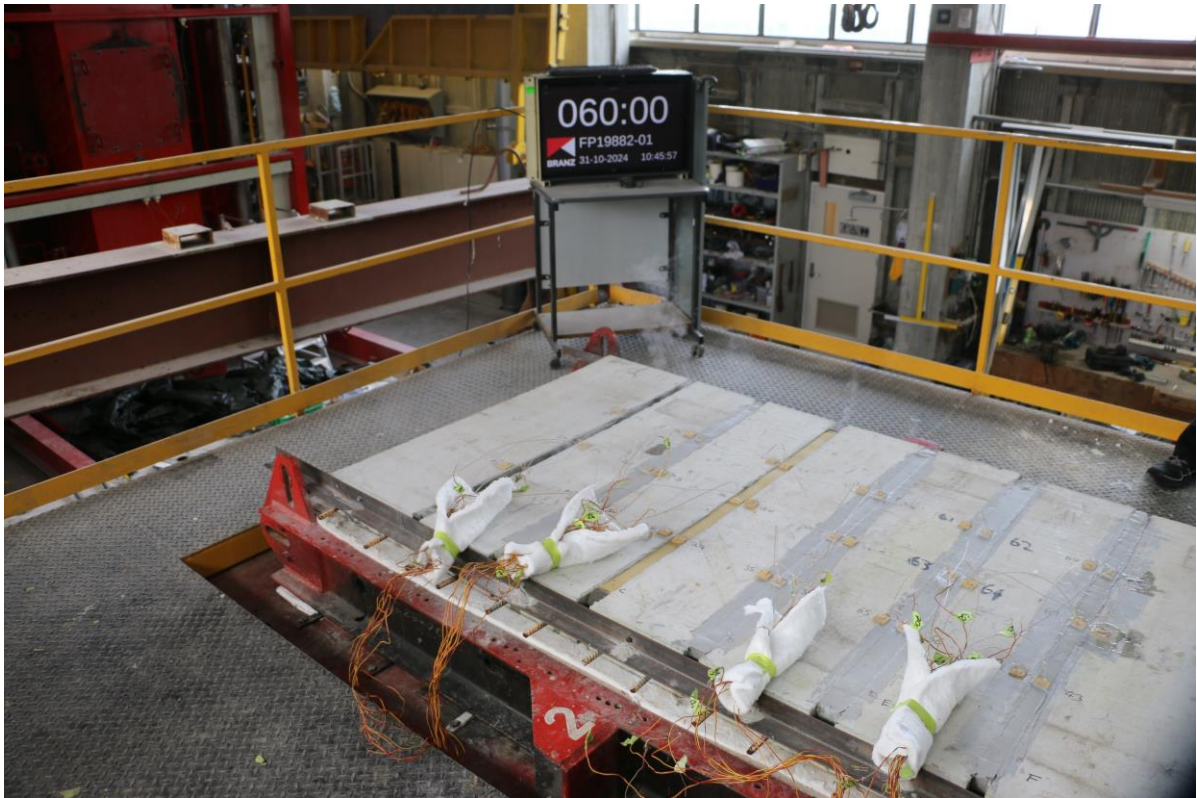
Photo 3: The Unexposed Face of the Test Assembly After a Duration of 60 Minutes

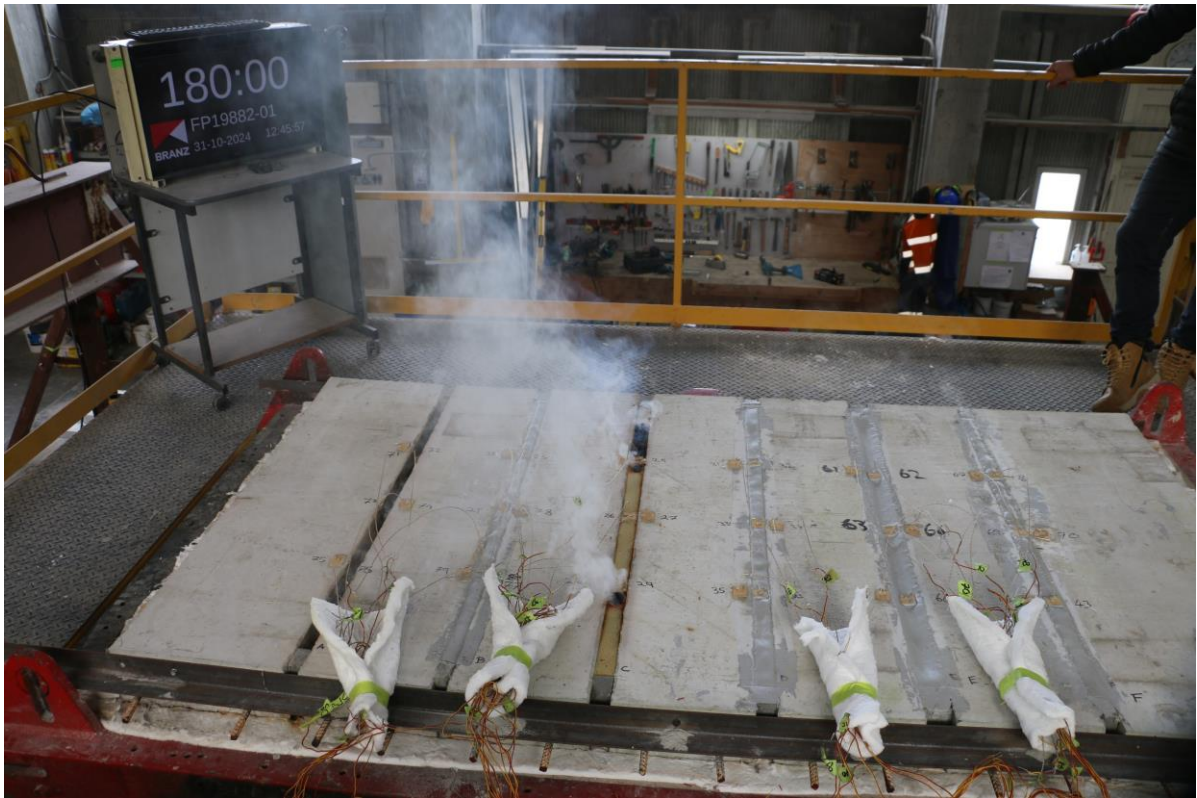
Photo 5: The Unexposed Face of the Test Assembly After a Duration of 180 Minutes

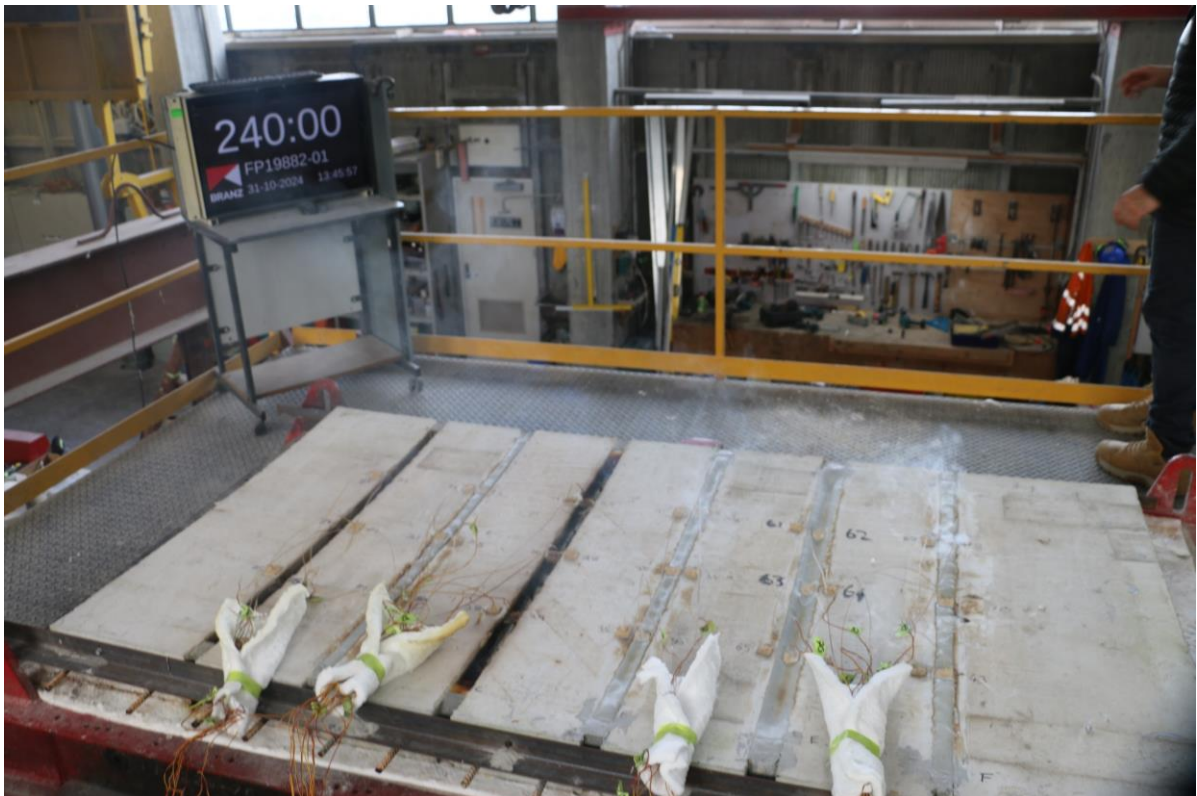
Photo 6: The Unexposed Face of the Test Assembly After a Duration of 240 Minutes

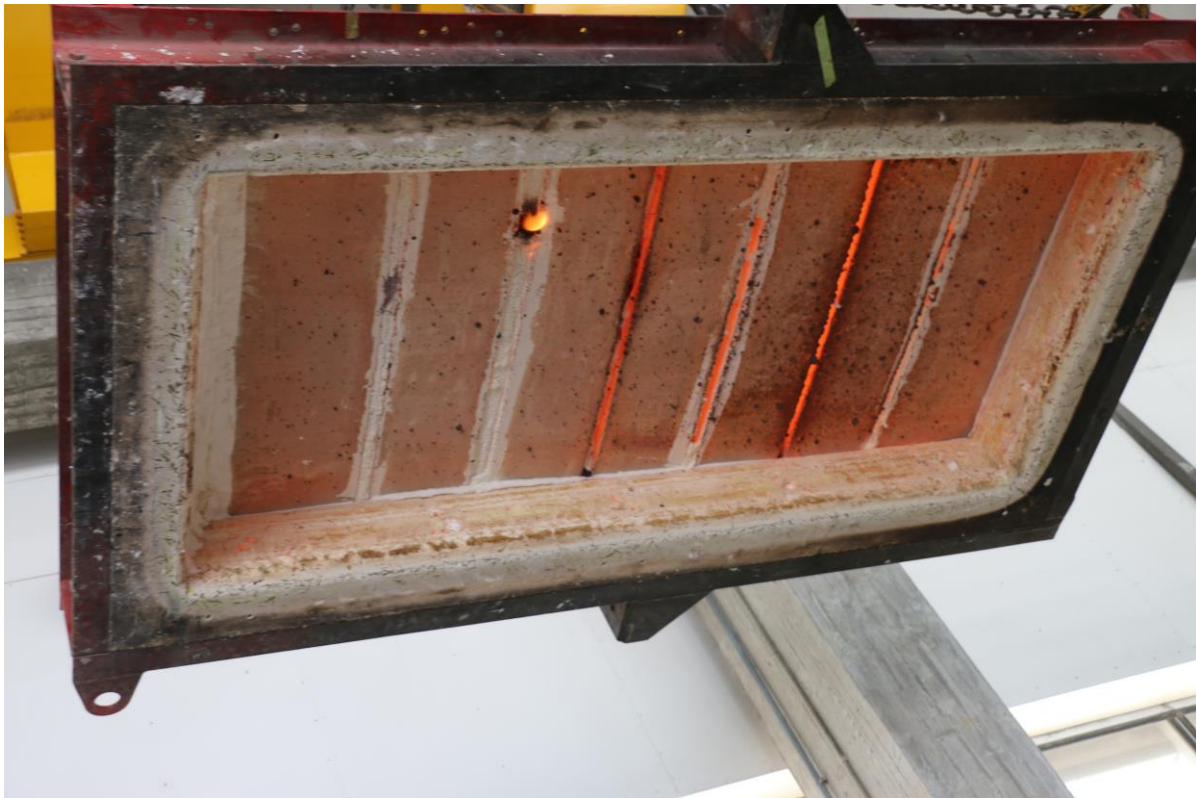
Photo 7: The Exposed Face of the Test Assembly Immediately After Testing
